Quick leak detection and repair of oil cables

Asset Management & Services
Emergency Response Solutions

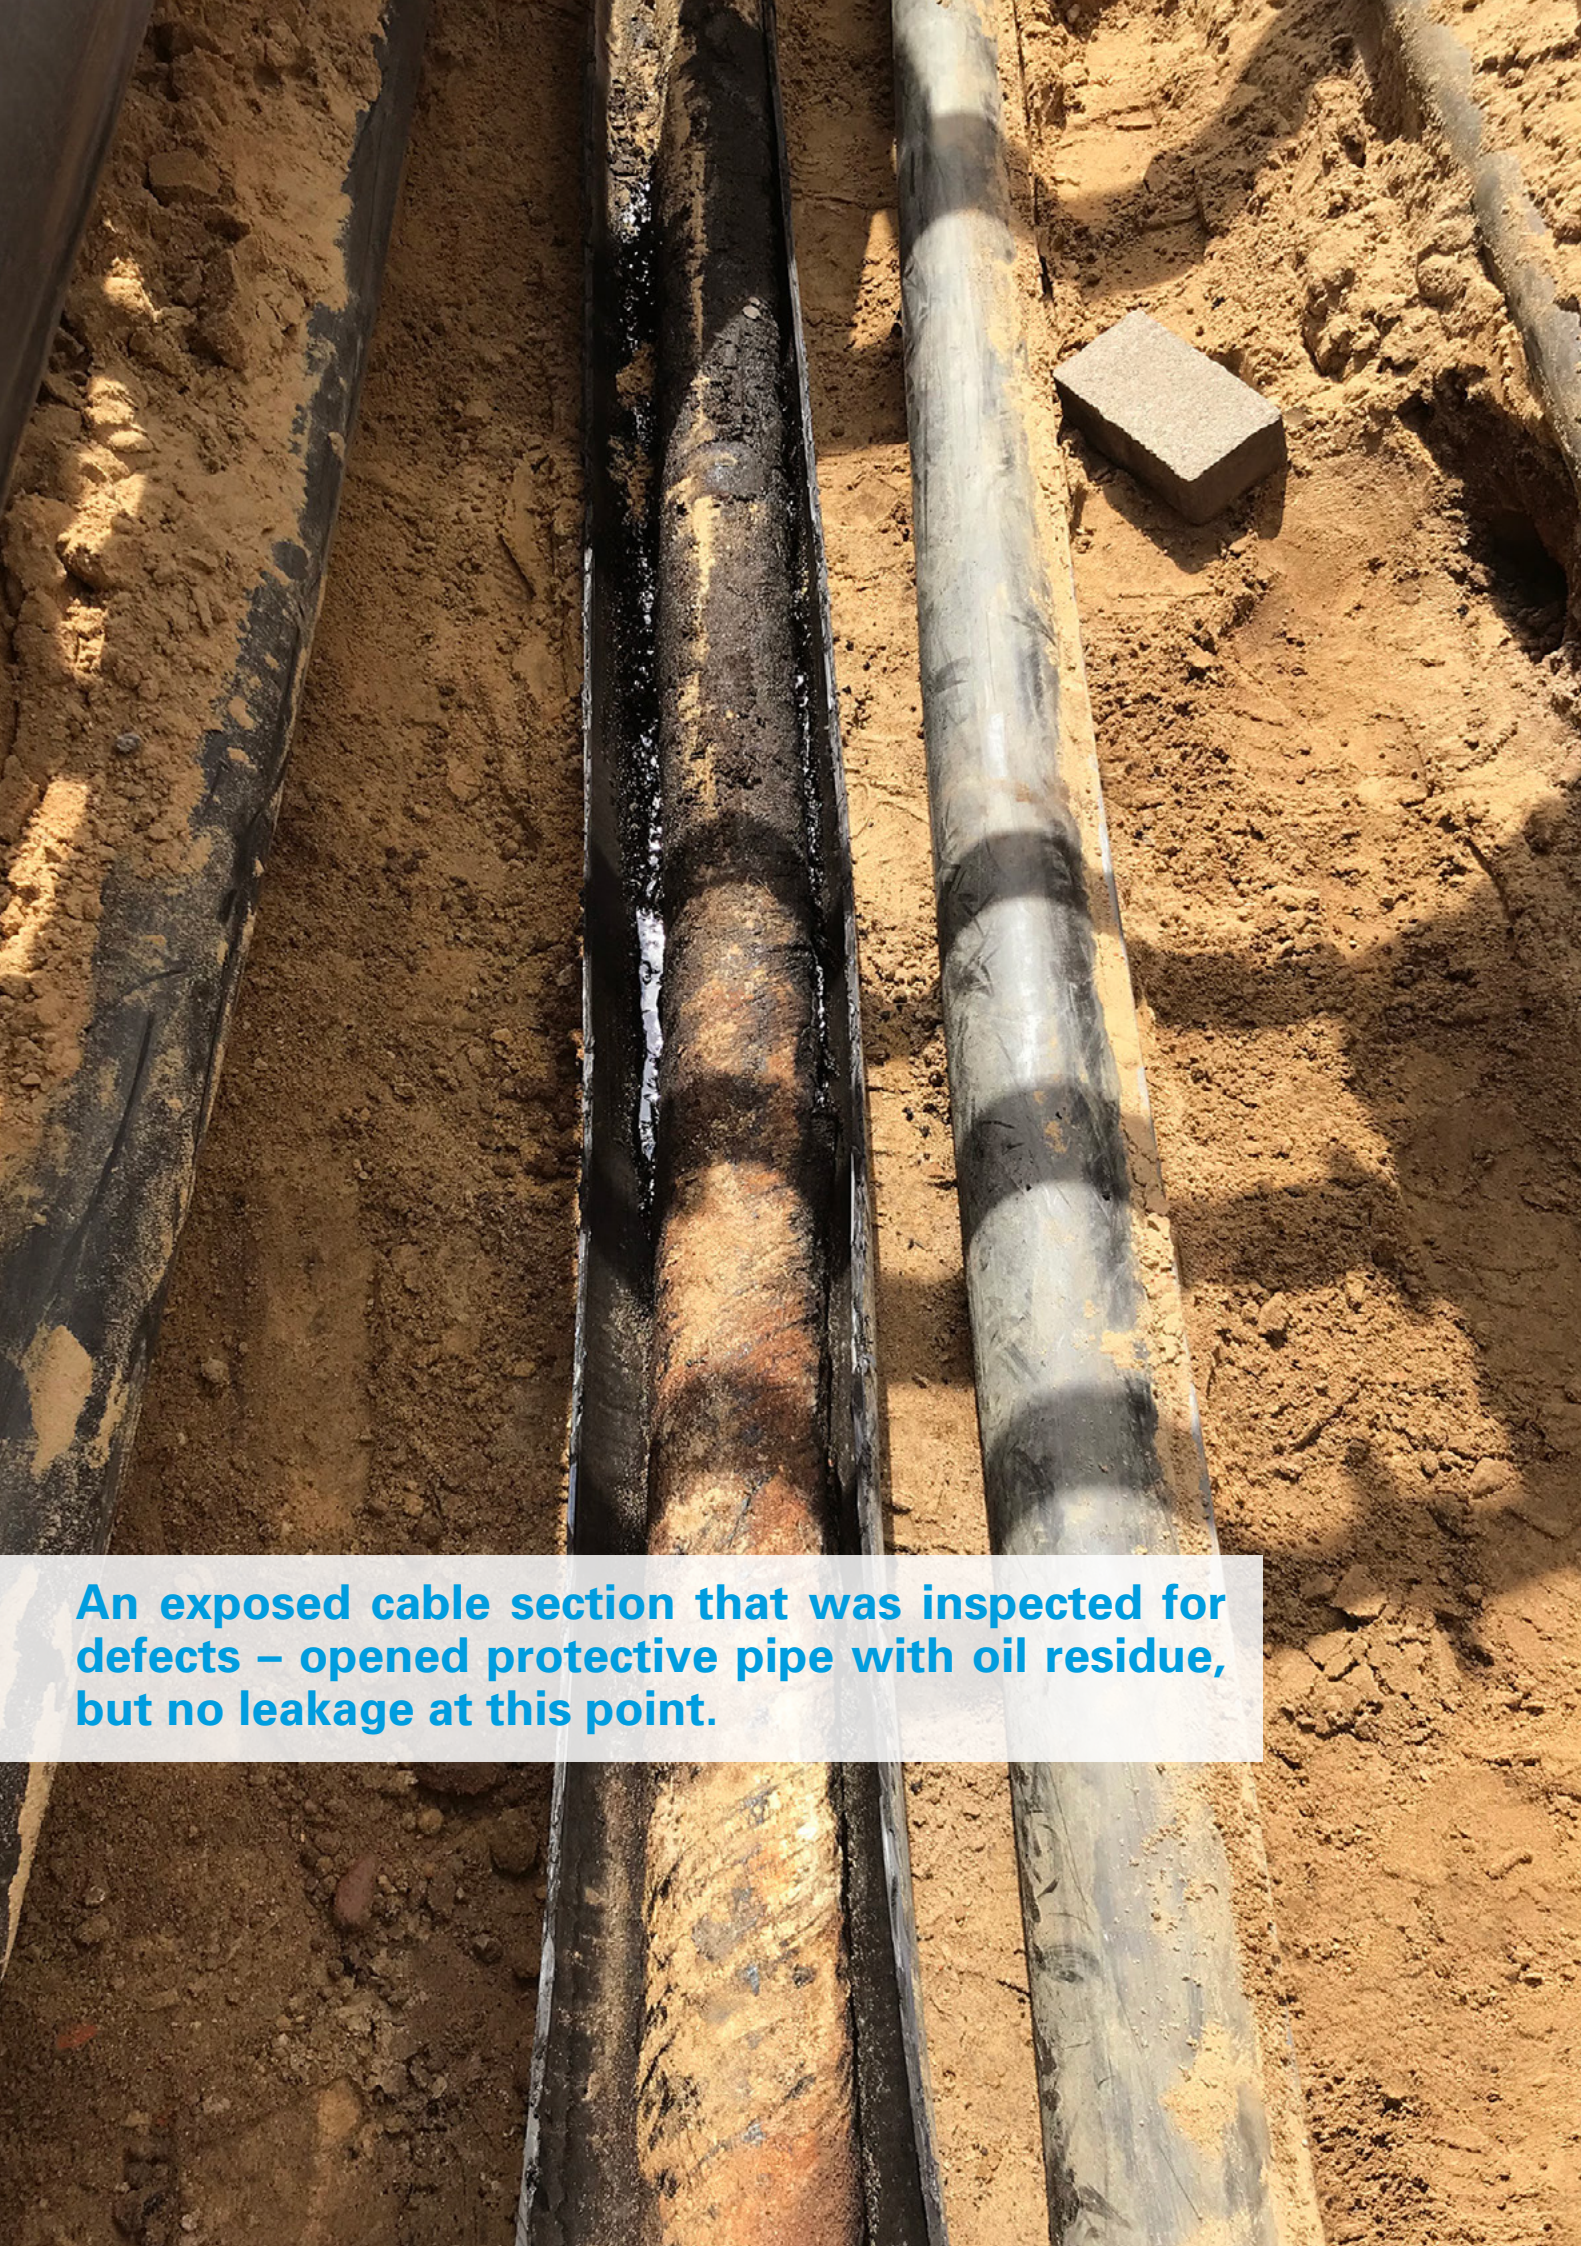
An exposed cable section that was inspected for defects – opened protective pipe with oil residue, but no leakage at this point.

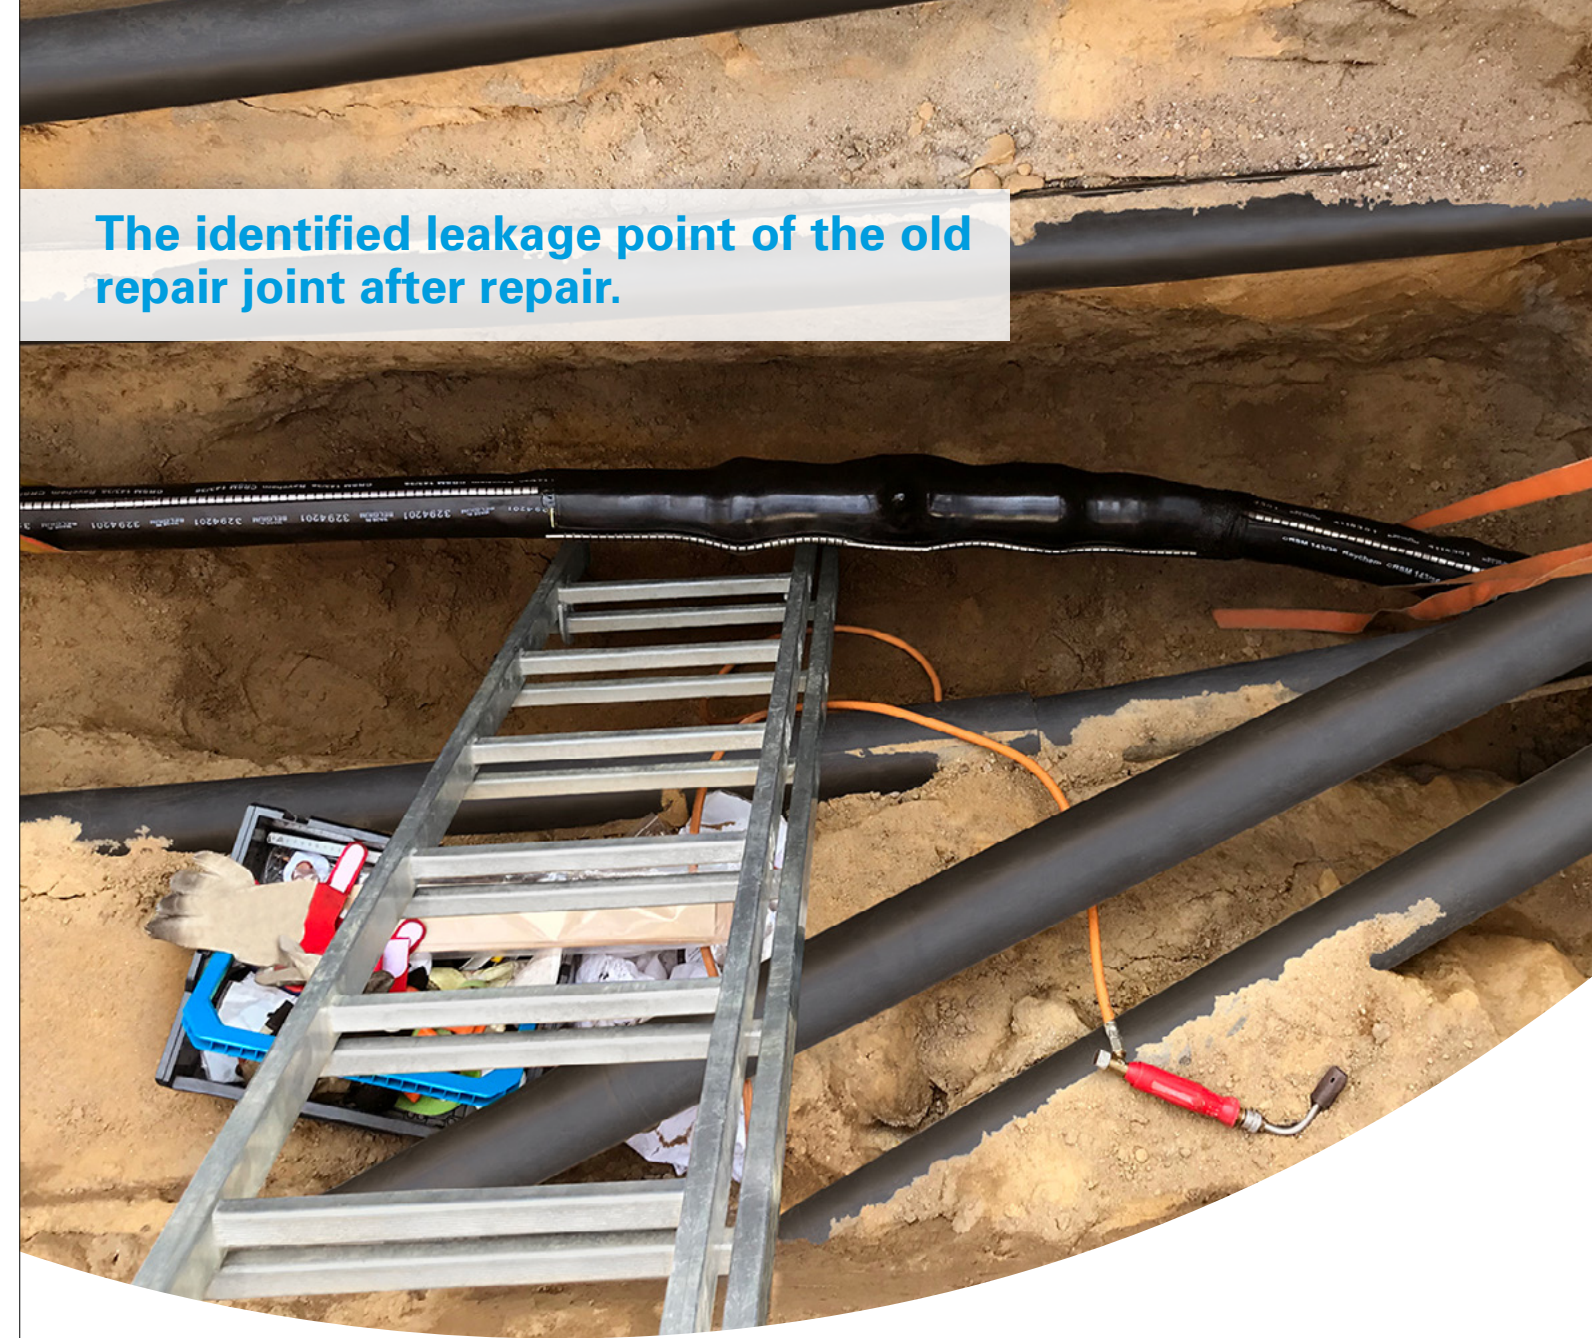
Brugg Cables, therefore, examined the three joints once again and was able to identify an oil leak in the first, an approximately 10-year-old repair joint. One repair seal showed leaks. The area around the seal was professionally sealed and reinforced. The pressure test after the repair showed no evidence of further relevant leaks, so the operation was completed.

The identified leakage point of the old repair joint after repair.
